State of California  
Department of California Highway Patrol

## 1989 Loma Prieta Earthquake Summary Report

# I-80 San Francisco-Oakland Bay Bridge and the I-880 Nimitz Freeway Collapse Summary

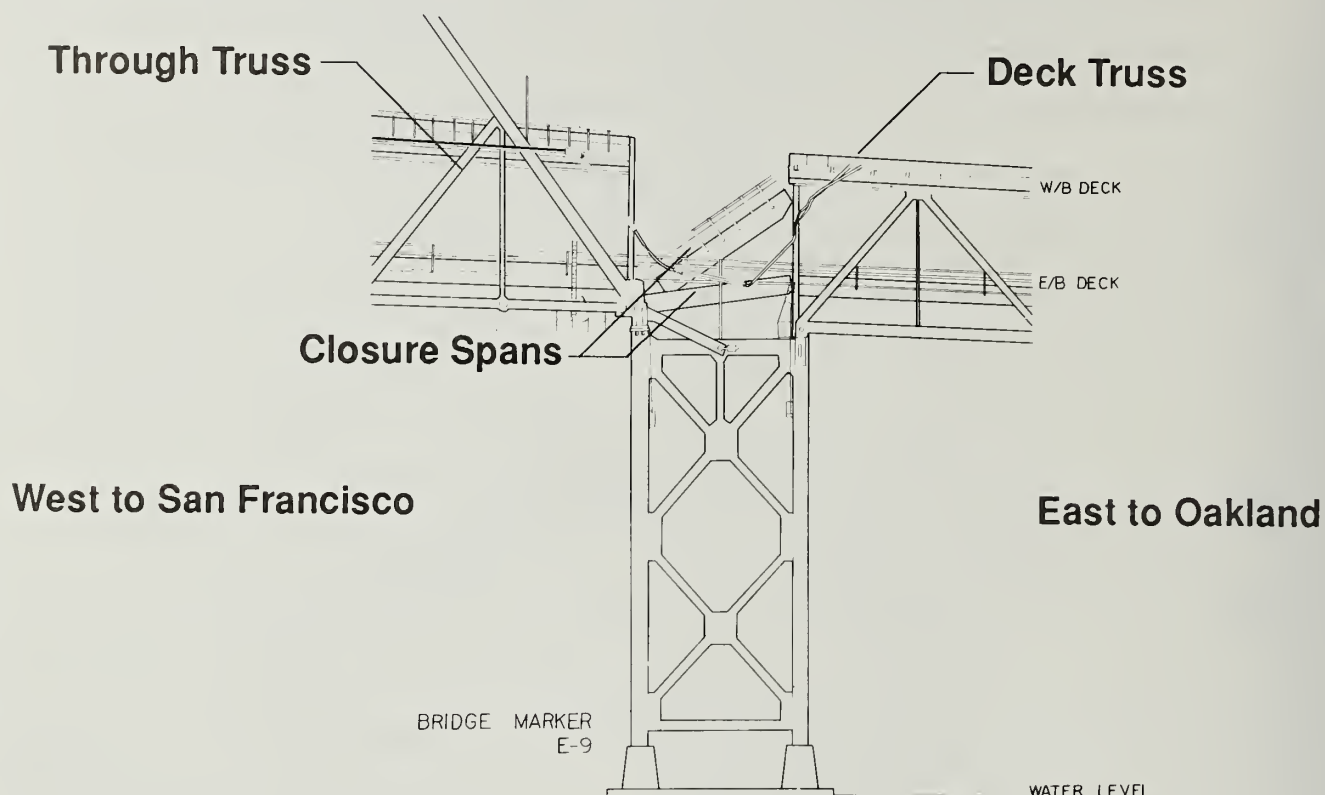
## Tower E-9

The earthquake induced horizontal and vertical forces in the trusses of the East Bay crossing. These forces caused the bolts connecting the deck truss sections to the east side of the E-9 tower to fail and permitted free movement across this support point.

An inspection indicated a minimum of ten inches of movement occurred with sufficient force to cause deformation of the roadway expansion assembly to the immediate east of the tower. This movement resulted in a final, at rest, displacement of the deck truss of 5-1/2 inches to the east, and 1 inch to the north. The two 50 foot closure spans over tower E-9 were rigidly attached to the deck truss to the east and were free moving on 6 inch bearing seats which were attached to the through truss to the west. As the trusses on the east side of the tower began to move, the closure spans moved off their bearing seats on the west side and fell.

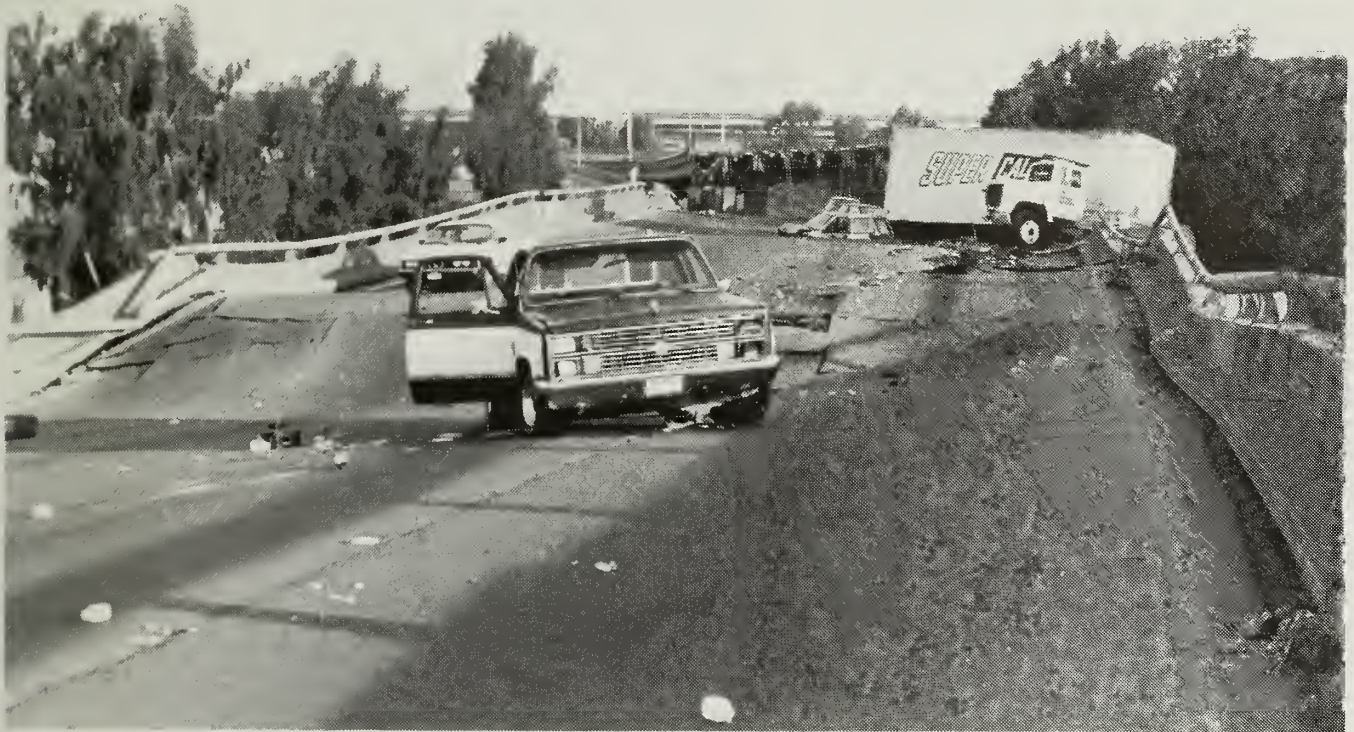
Pick-up truck at span 107 of Cypress Street Viaduct upper deck, "Big-rig" tractor-trailer at span 109

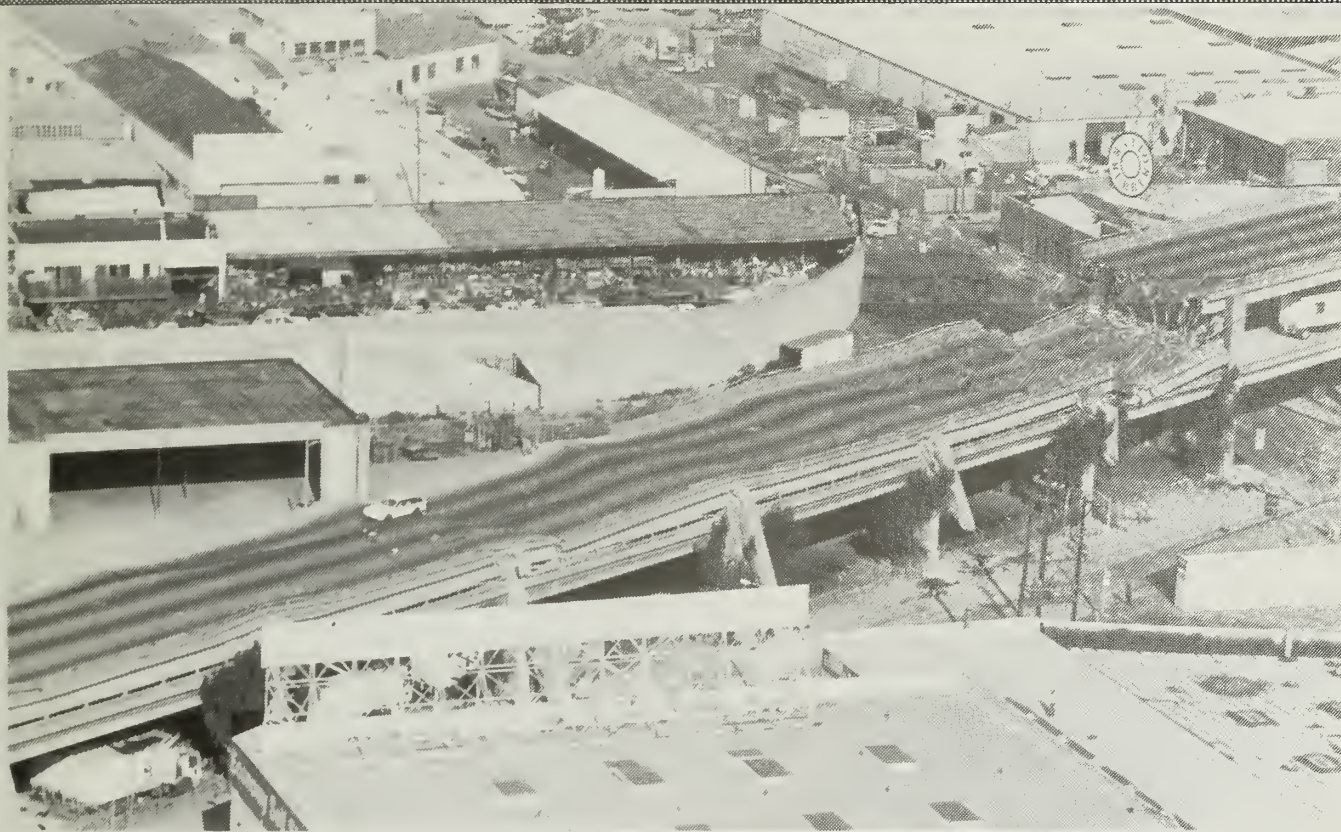
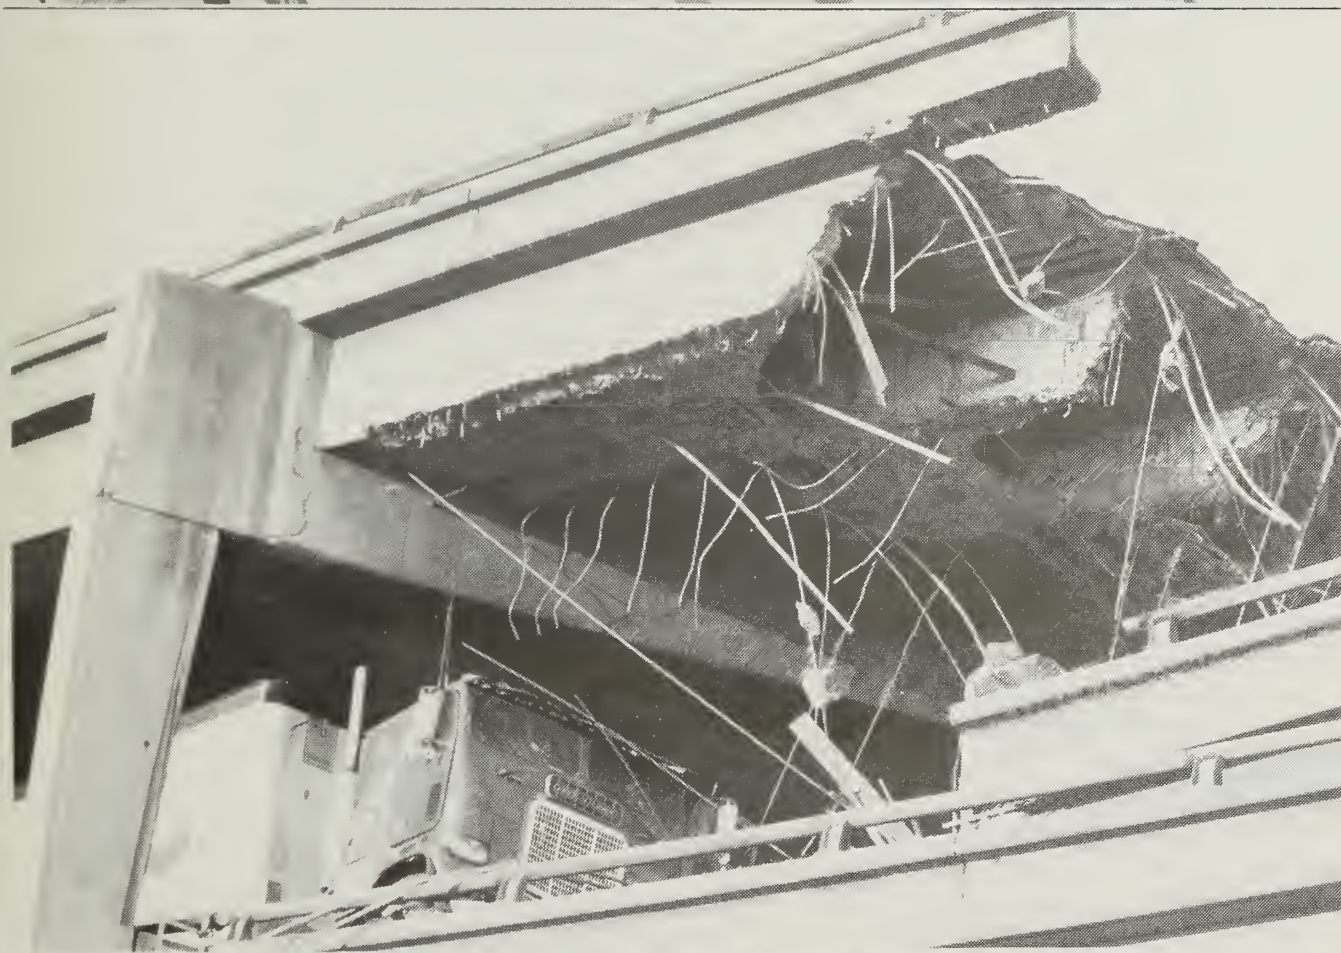
Top photograph shows the Cypress Street Viaduct failure from bents 90 to 96  
Bottom photograph shows a close-up of bent 97 and V-74, a Freightliner tractor/trailer

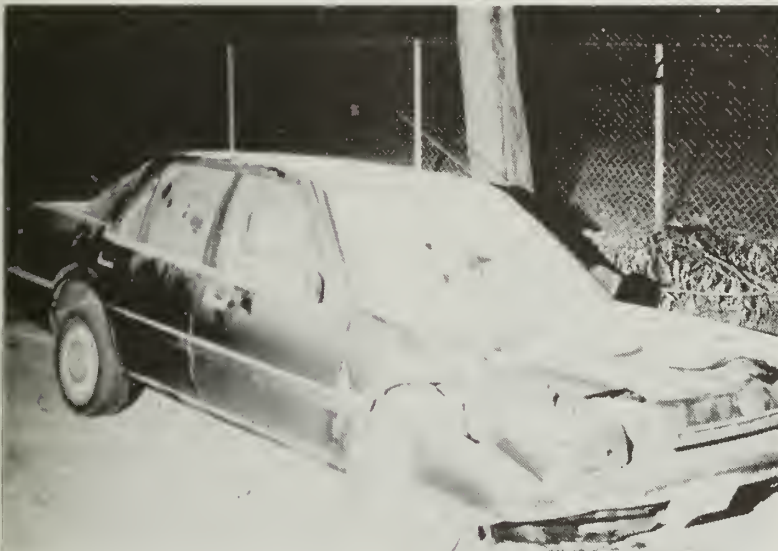
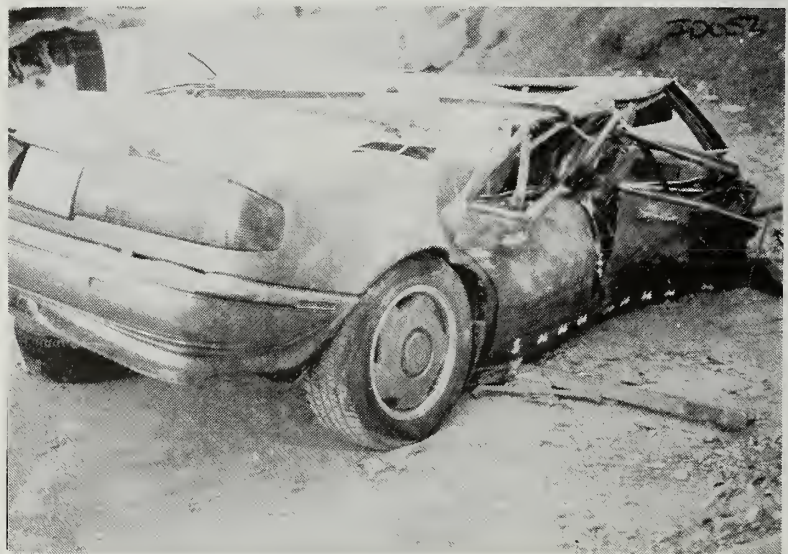
V-49

the right (east) side popping out, and then a large sheet of concrete fell on her vehicle.

Approximately four (4) seconds after the structure's strong motion began, the upper deck support columns at Bent 104 failed and the upper deck collapsed.

The Pontiac sustained total damage as a result of being crushed. It was removed from the structure on November 7, 1989, at approximately 1455 hours, and was hauled from the scene.

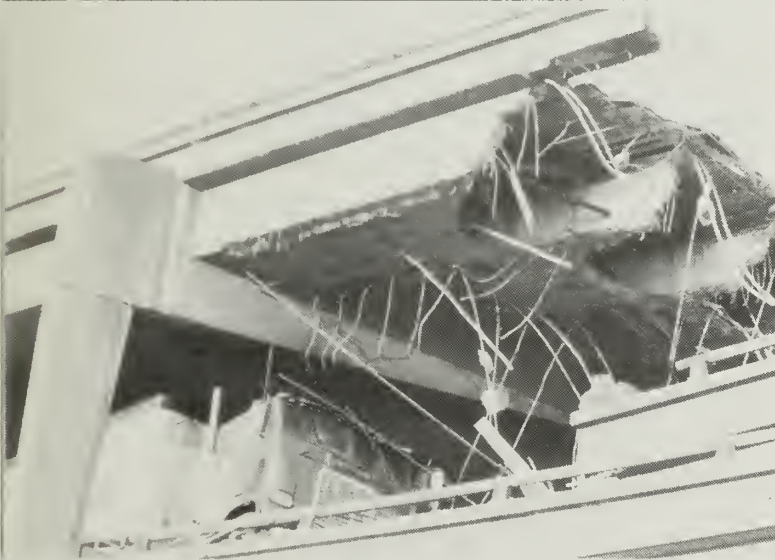
V-74

The tractor/trailer sustained moderate damage to the top and sides as a result of being struck by pieces of falling concrete and extrication from the structure. The tractor also sustained damage to the front and side as a result of the impact with the barrier rail. The tractor and its trailer were removed from the structure on November 6, 1989, at approximately 1550 hours and 1605 hours, and were towed from the scene.
